PLANS FOR ELIMINATION OF SHOALING
IN
THE VICINITY OF HEAD OF PASSES, MISSISSIPPI RIVER
HYDRAULIC MODEL INVESTIGATION

TECHNICAL MEMORANDUM NO. 2-356

WATERWAYS EXPERIMENT STATION
VICKSBURG, MISSISSIPPI

FEBRUARY 1953

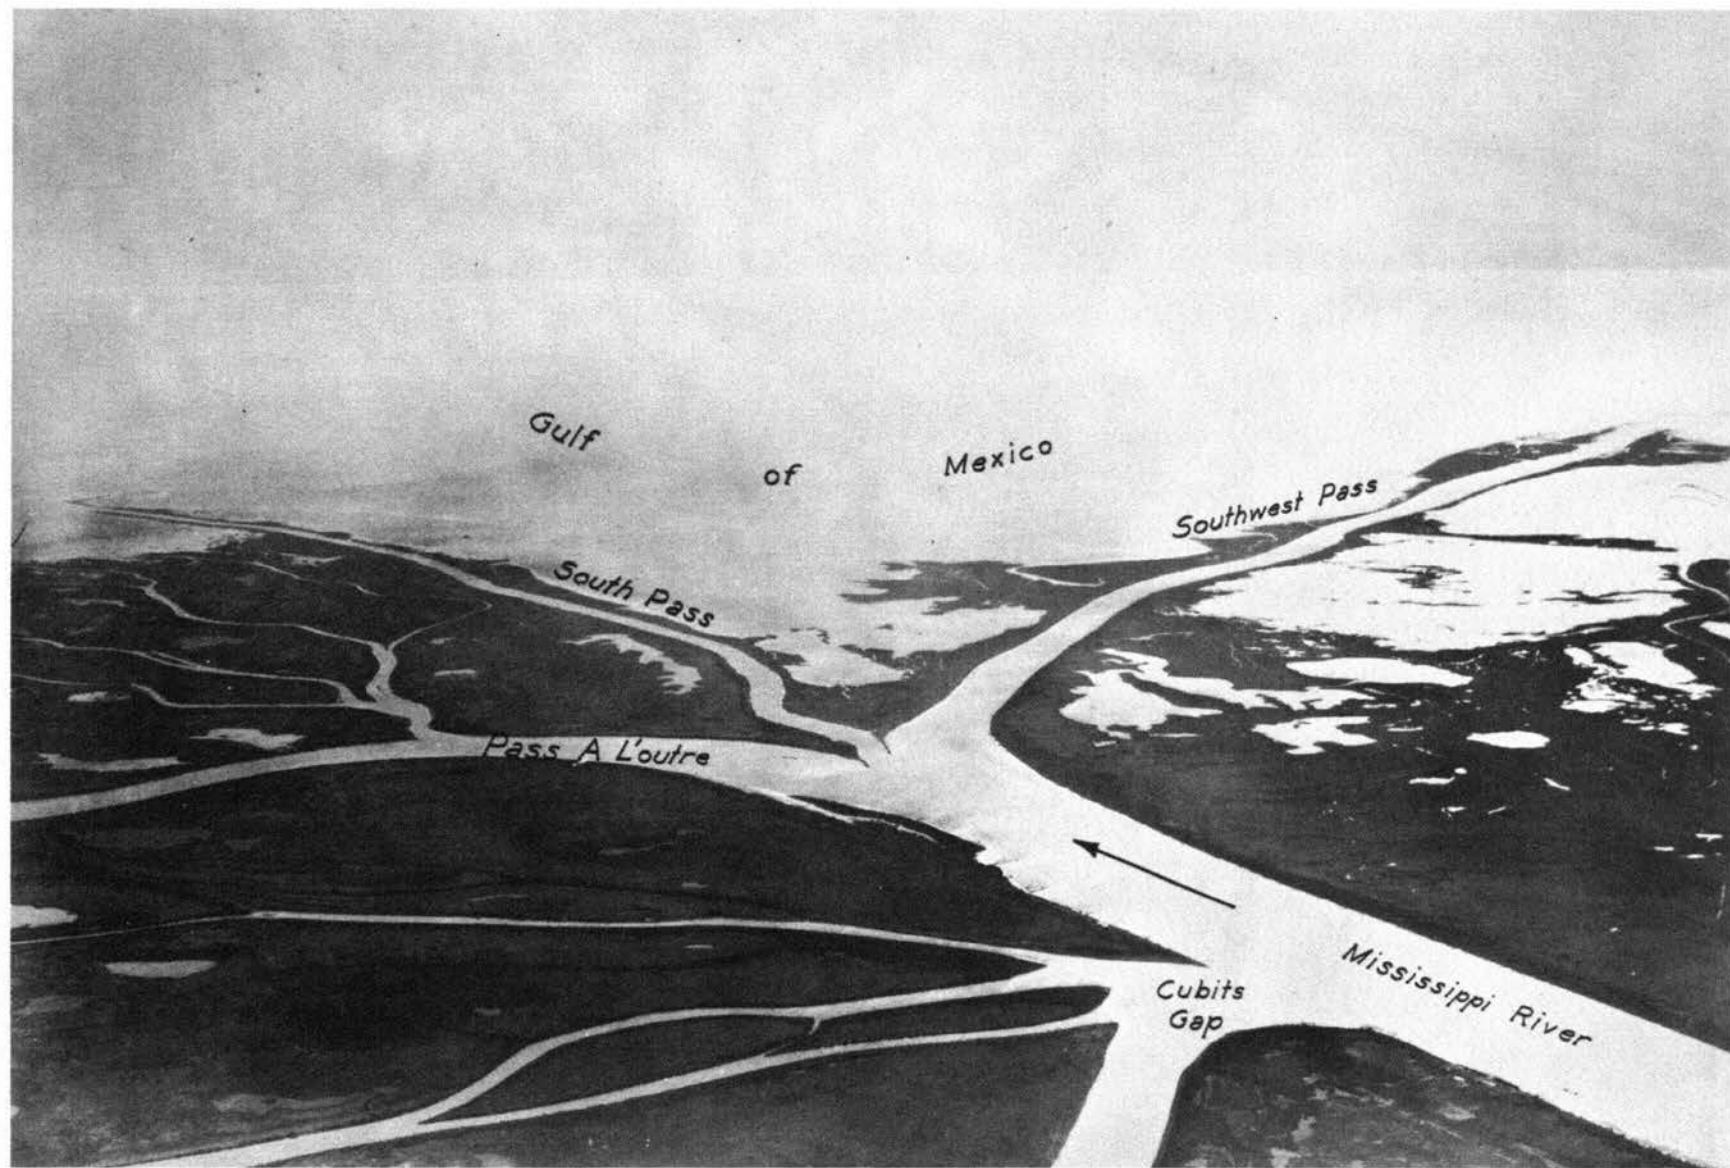
FRONTISPIECE. Head of Passes

1. The Head of Passes of the Mississippi River is located approximately 95 miles below New Orleans, Louisiana, and is the upper end of the three principal outlets to the Gulf of Mexico. Reference to the frontispiece and figure 1 will serve to establish the geographical location of the problem area.

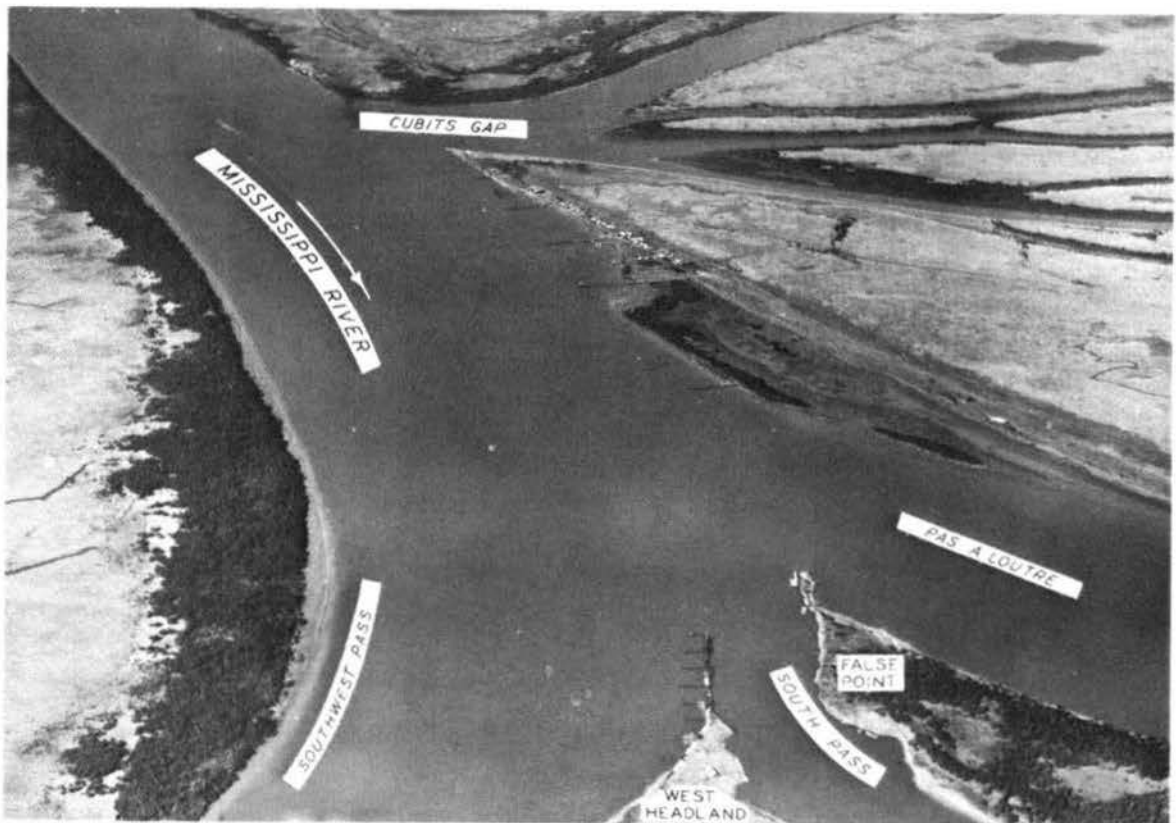
Fig. 1. Aerial view of the Head of Passes reach looking upstream

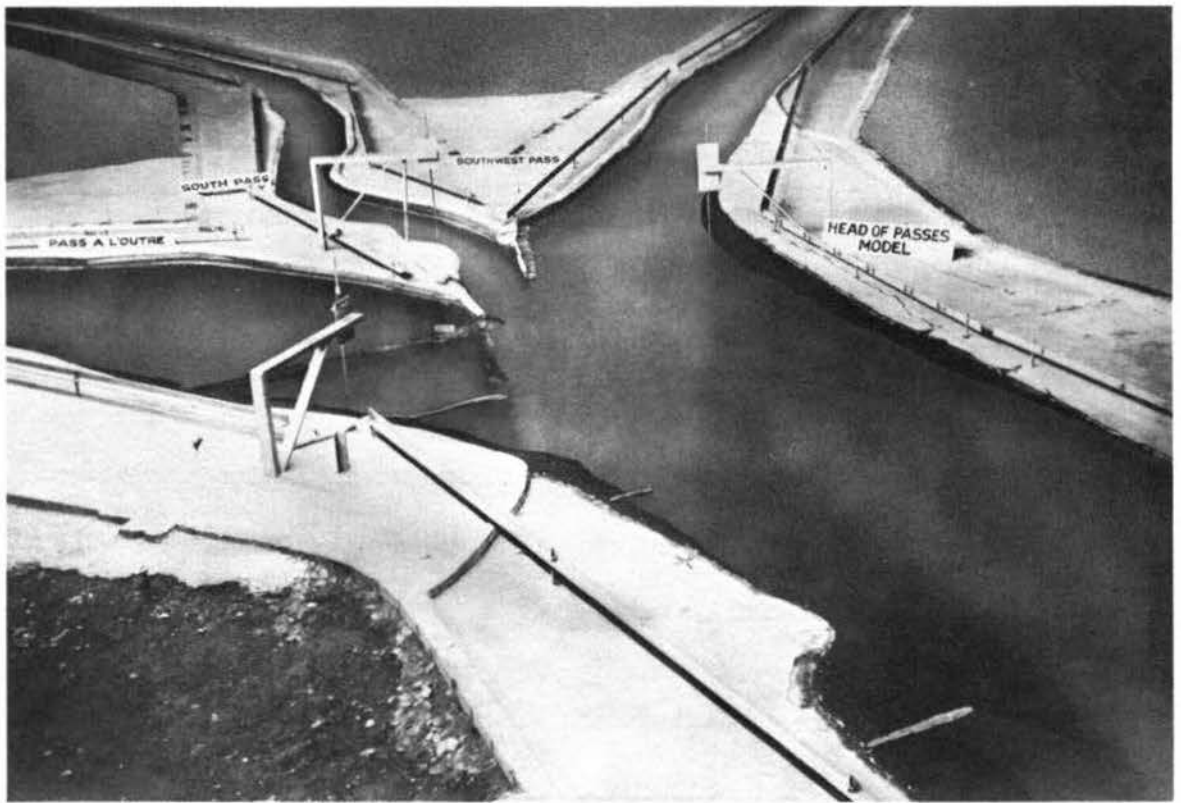
Fig. 2. Downstream view of the model showing the Head of Passes area

12. The Head of Passes model reproduced the 7-mile reach of the Mississippi River immediately above Head of Passes, all of South and Southwest Passes, the upper 2 miles of Pas a Loutre, and the upper one-half mile of Cubits Gap (see figs. 2 and 3, page 8). The model limits included sufficient overbank area to permit the reproduction of flow slightly higher than bankfull stages.

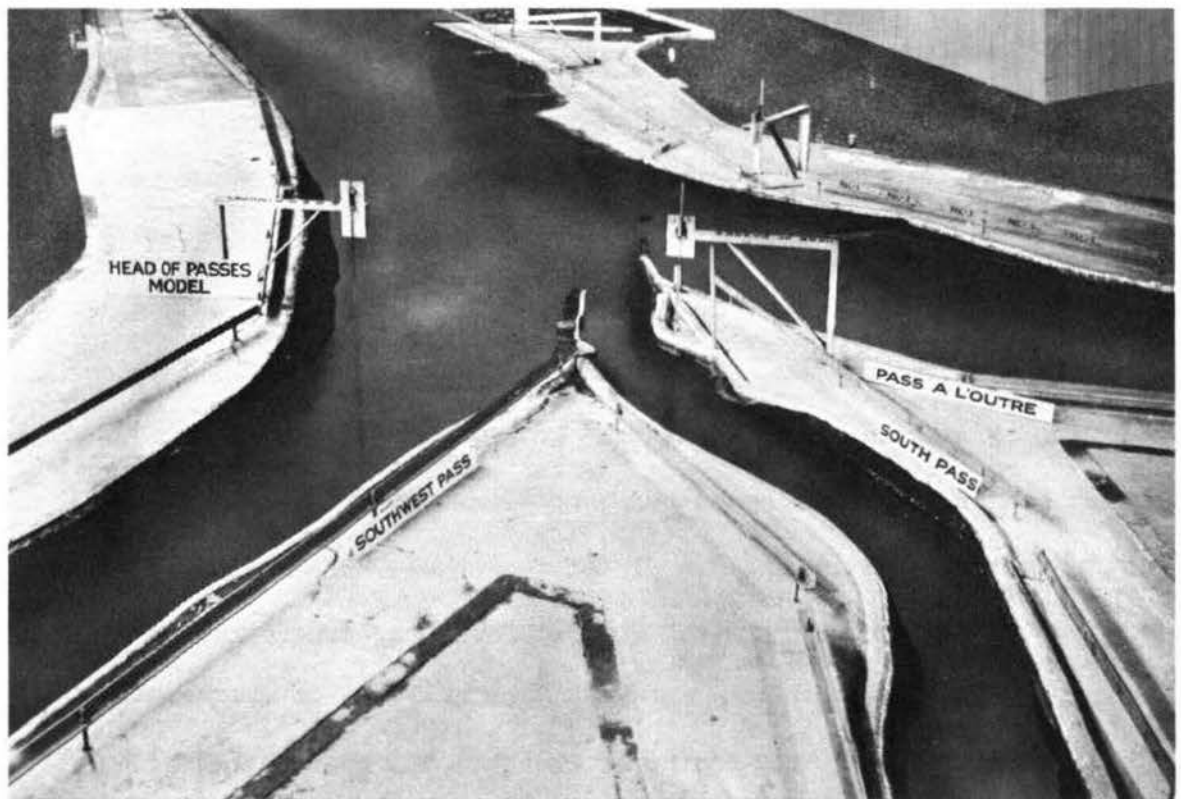
Fig. 3. Upstream view of the Head of Passes reach

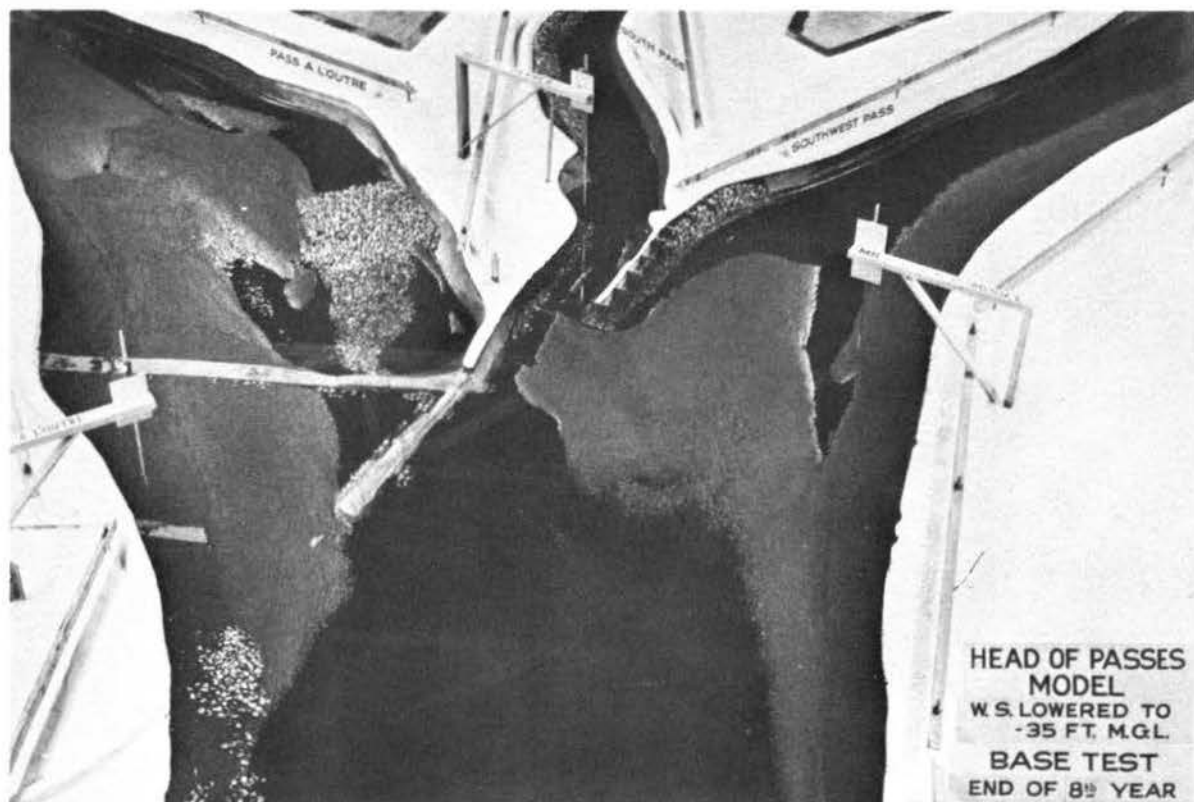
Photograph 1. Base test; test 2; end of test. Downstream view of model bed at Head of Passes. Note shoal area at head of Southwest Pass

34. The final results of the base test are shown on plate 6 and photograph 1. The results of this test can be determined from a comparison of plate 5, showing the condition of the model bed at the start of the test, with plate 6, showing the condition of the model bed at the end of the test. The principal effects noted during the base test are described in the following paragraphs.

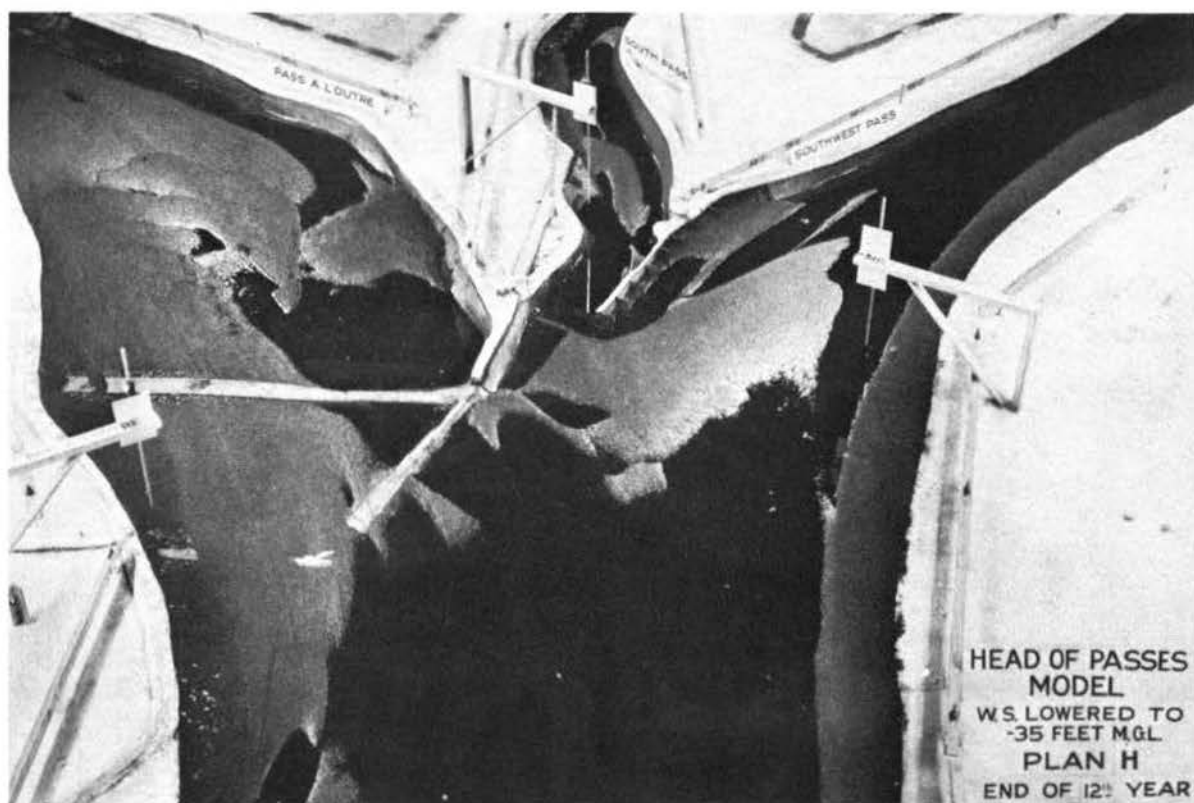
Photograph 2. Plan H; test 10; end of test. Downstream view of model bed at Head of Passes. Note shoal area at the entrance of South and Southwest Passes

56. Results. The results of this test (see plate 15 and photograph 2) indicated that the unprotected fills included in plan H would be scoured and the dredge cut would eventually be completely filled. Since none of the improvement works would be permanent, the ultimate condition of the channel would be the same as if no improvement works had been constructed. Detailed results of plan H were as follows:

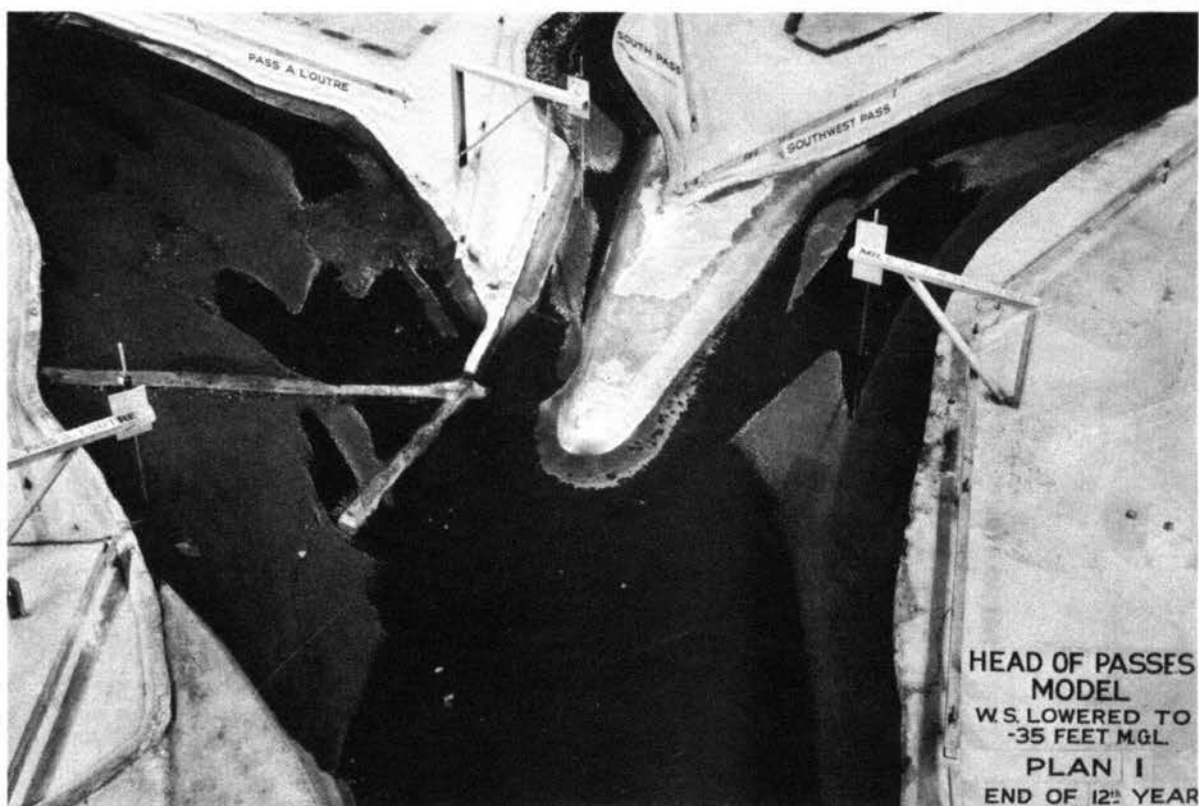
Photograph 3. Plan I; test 11; end of test. Downstream view of model bed at Head of Passes. Note split channel in Southwest Pass and shoal area at entrance of South Pass

58. Results. The results of this test (see plate 16 and photograph 3) indicated that with plan I installed depths would be increased in the channel above Head of Passes but that a satisfactory channel through the entrance to Southwest Pass would not be obtained.

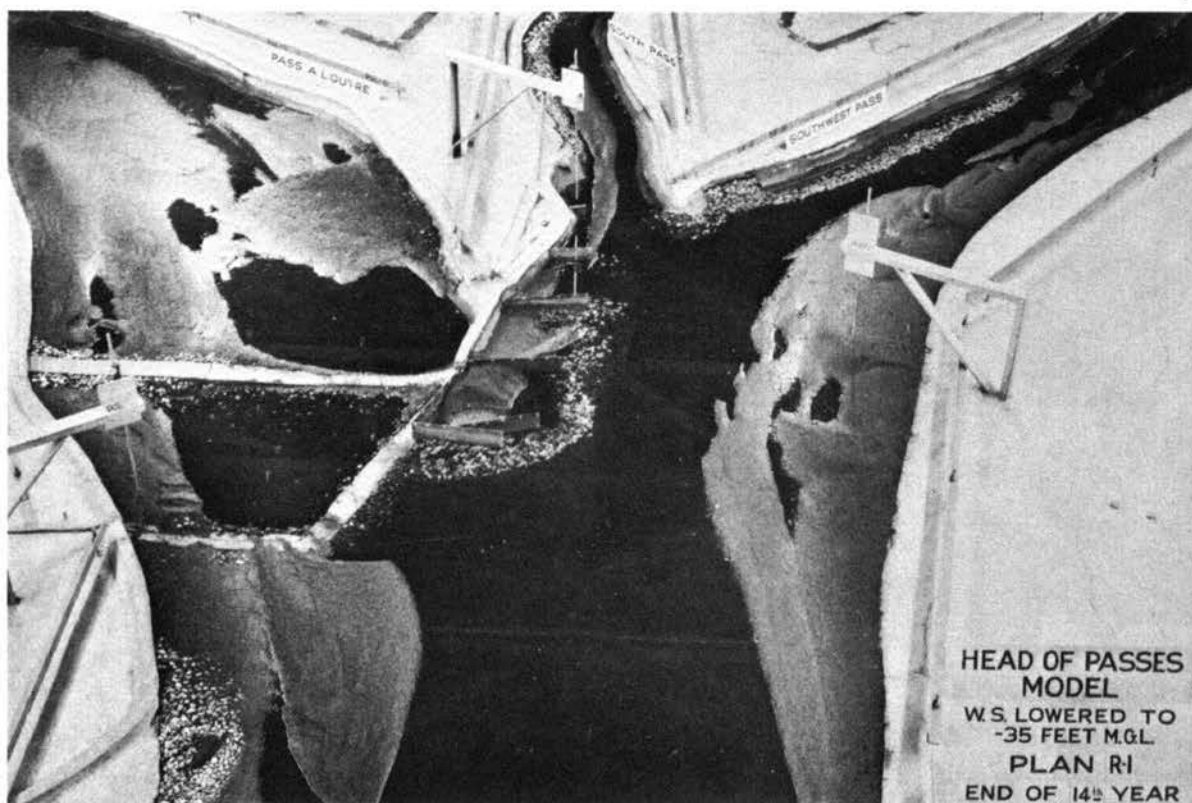
Photograph 4. Plan R-1; test 21; end of test. Downstream view of model bed at Head of Passes. Note channel alignment into South and Southwest Passes

82. Results. Plan R-1 produced the most satisfactory channel of any of the plans tested thus far (see plate 26 and photograph 4). Shoaling in the channel above Head of Passes formed a bar of less than 35-ft depth from along the right bank near Cubits Gap to about the center of the channel near Pilottown; a 40-ft channel of about 1000-ft width was obtained along the left bank. Considerable scouring occurred along the proposed dikes and extensions. Depths of more than 80 ft were obtained opposite the entrance to Pas a Loure above the proposed dike system. Channel depths and suitable channel alignment into Southwest Pass were maintained by dredging at the ends of runs 2 and 4. Only a small amount of dredging was required at the end of run 4, and a 600-ft by 40-ft channel was maintained without dredging for the remainder of the test. Most of the material scoured from along the proposed dikes was moved into South and Southwest Passes. The large movement of material into Southwest Pass shoaled the channel below mile 1 to less than 35 ft early in the test. Most of the material forming this shoal was scoured out after the channel upstream had become stable, indicating that under stable conditions this shoal would probably disappear, but a channel of sufficient depth in this area had not been attained by the end of the test. Considerable shoaling occurred in South Pass below the head and below mile 2. A bar which formed below the extended left-bank

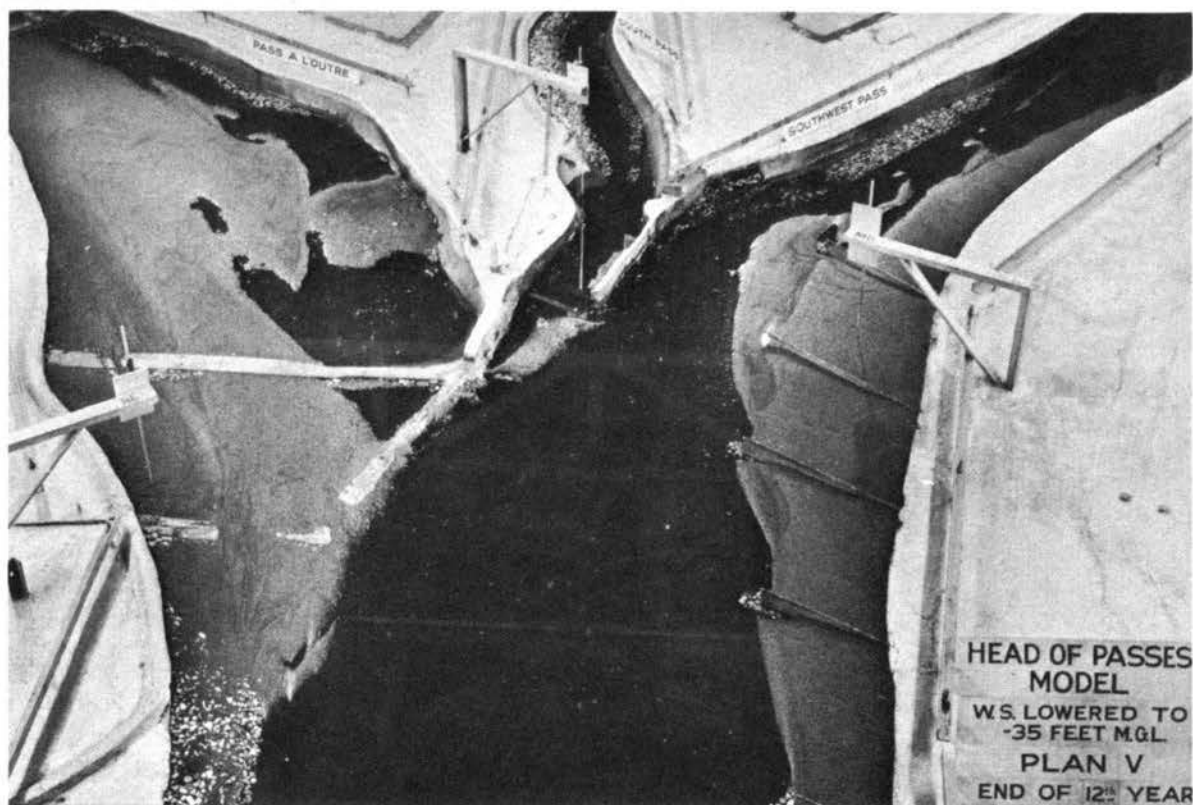
Photograph 5. Plan V; test 27; end of test. Downstream view of model bed at Head of Passes. Note channel alignment into Southwest Pass

92. Results. The results of this test (plate 31 and photograph 5)

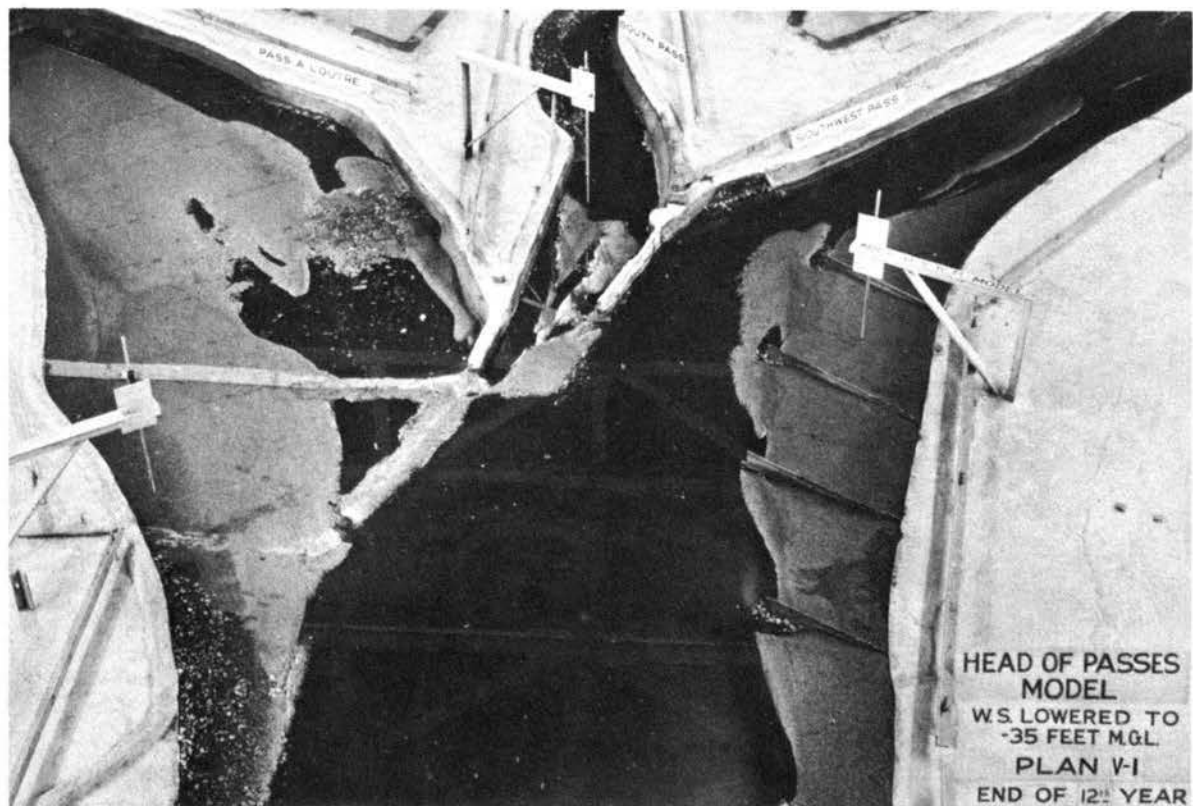
Photograph 6. Plan V-1; test 29; end of test. Downstream view of model bed at Head of Passes. Note channel alignment into Southwest Pass and shoaling condition at head of South Pass

96. Results. The results of plan V-1 (see plate 33 and photograph 6) were similar to those of plan V (described in paragraph 92) except at the head of South Pass. The removal of False Point increased the channel width and cross-sectional area in that vicinity and caused considerable shoaling to occur along the West Headland indicating that removal of this point would not effect the desired channel improvement. The eddy caused by False Point was eliminated; however, no change was noted in the deep scour hole.

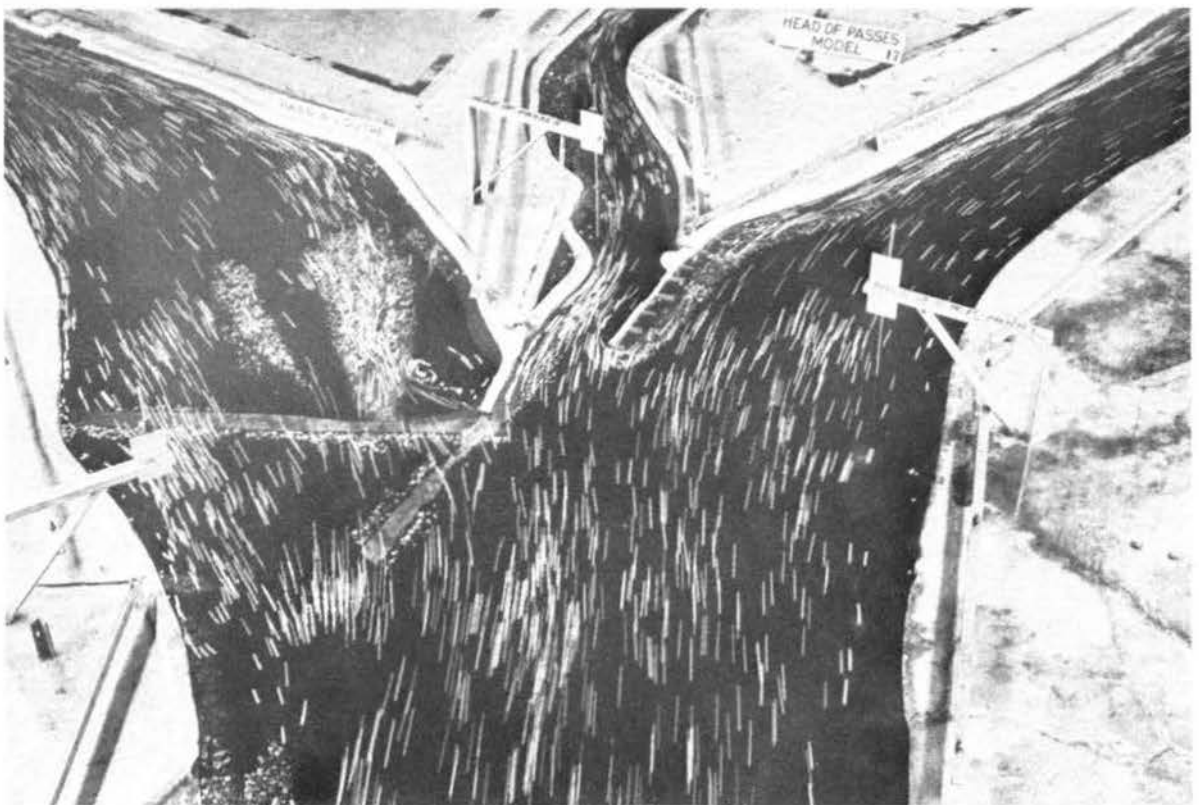
Photograph A1. Base test; test 34. Downstream view of Head of Passes area showing current alignment during the 17-ft stage

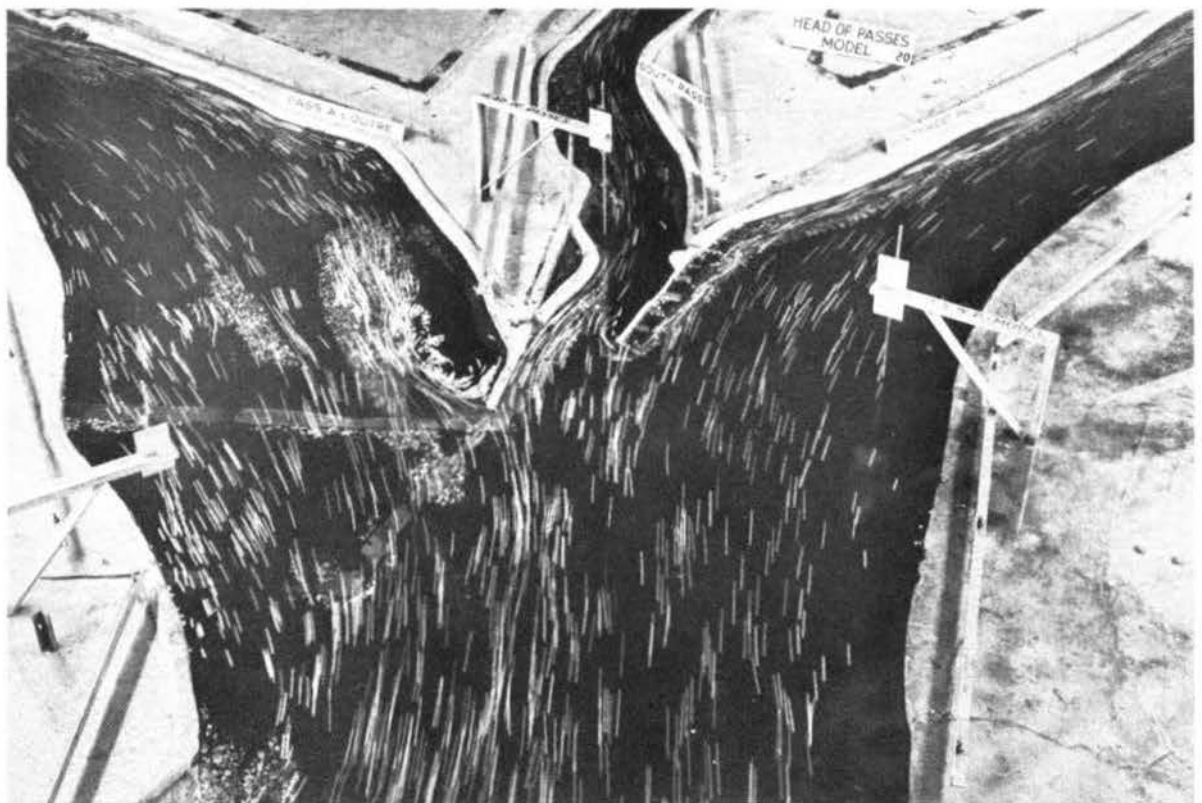
Photograph A2. Base test; test 34. Downstream view showing current alignment into the three main passes during the 20-ft stage. Note eddy formed behind the East Headland

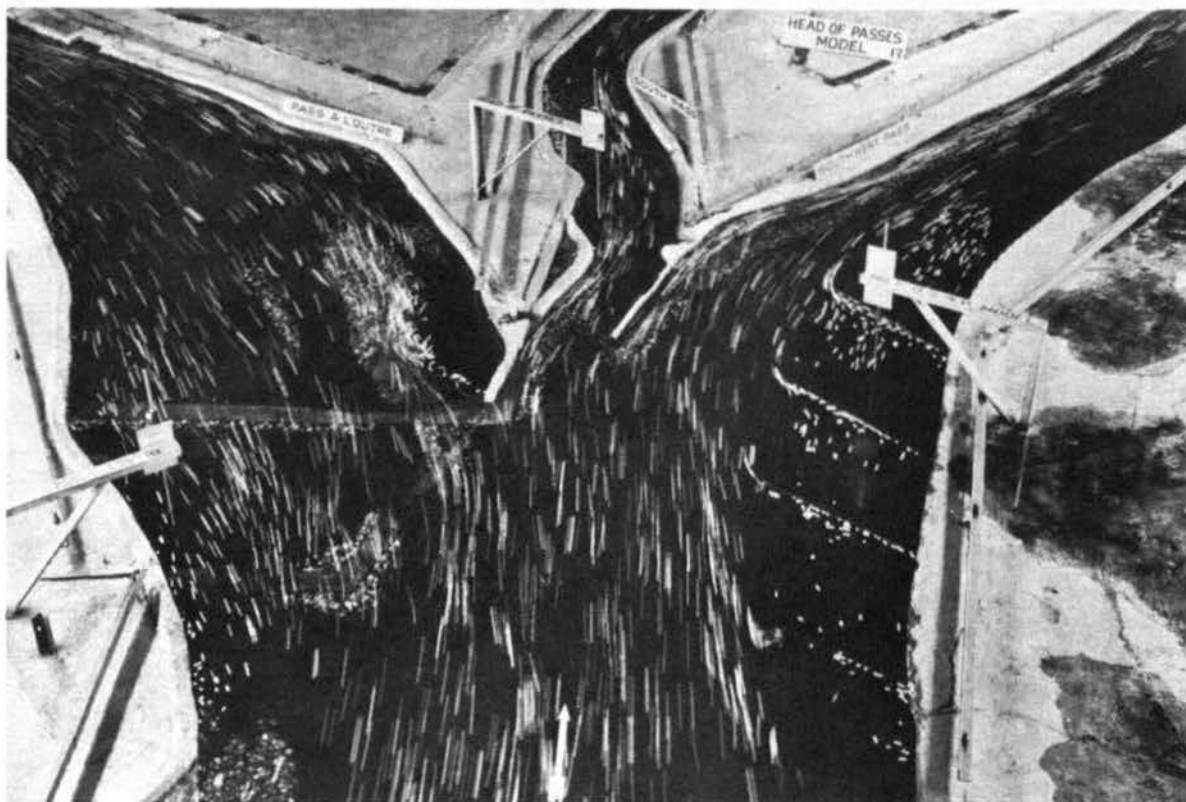
Photograph A3. Plan V; test 35; 17-ft stage. The right-bank dikes produced sufficient contraction, thus enabling Southwest Pass to maintain a navigable channel

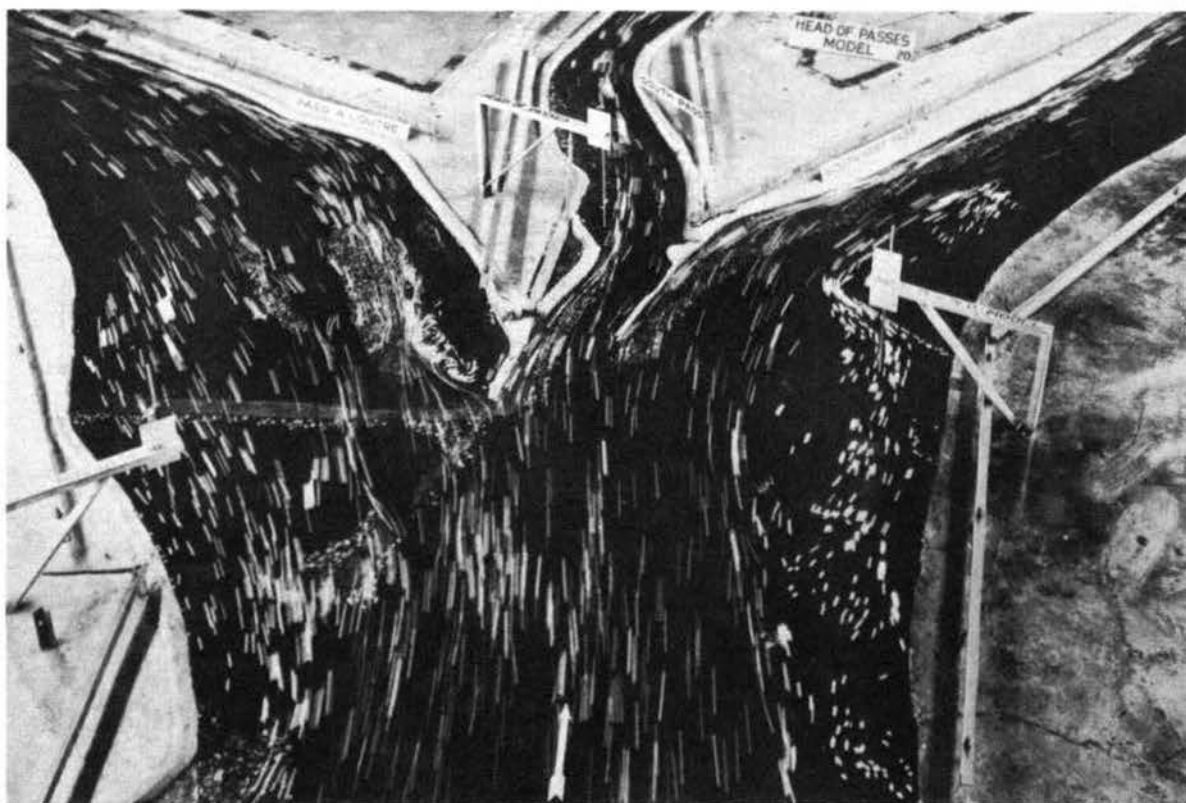
Photograph A4. Plan V; test 35; 20-ft stage. The right-bank dikes were not endangered by the 20-ft flood stage

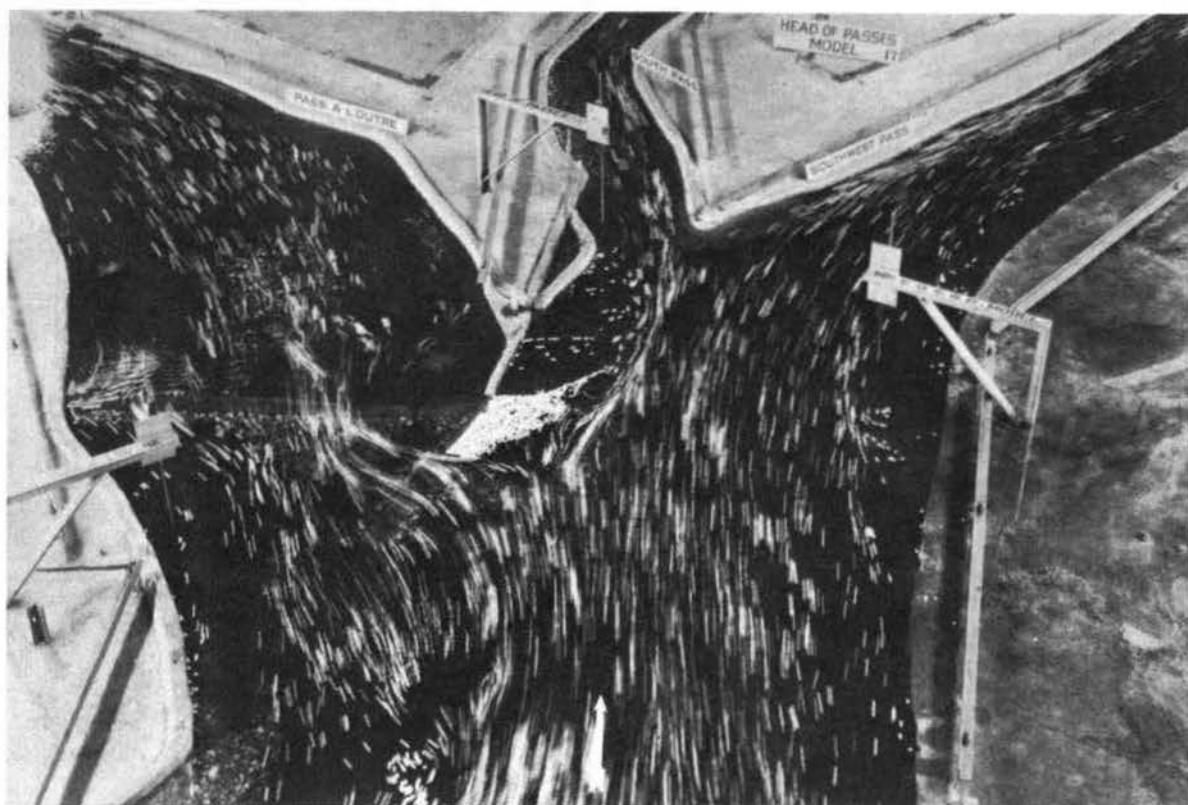
Photograph A5. Plan R-1; test 36; 17-ft stage. A large subsurface eddy was formed between the Pas a Loutre submerged deflecting dike and submerged sill by the extension of the East Headland

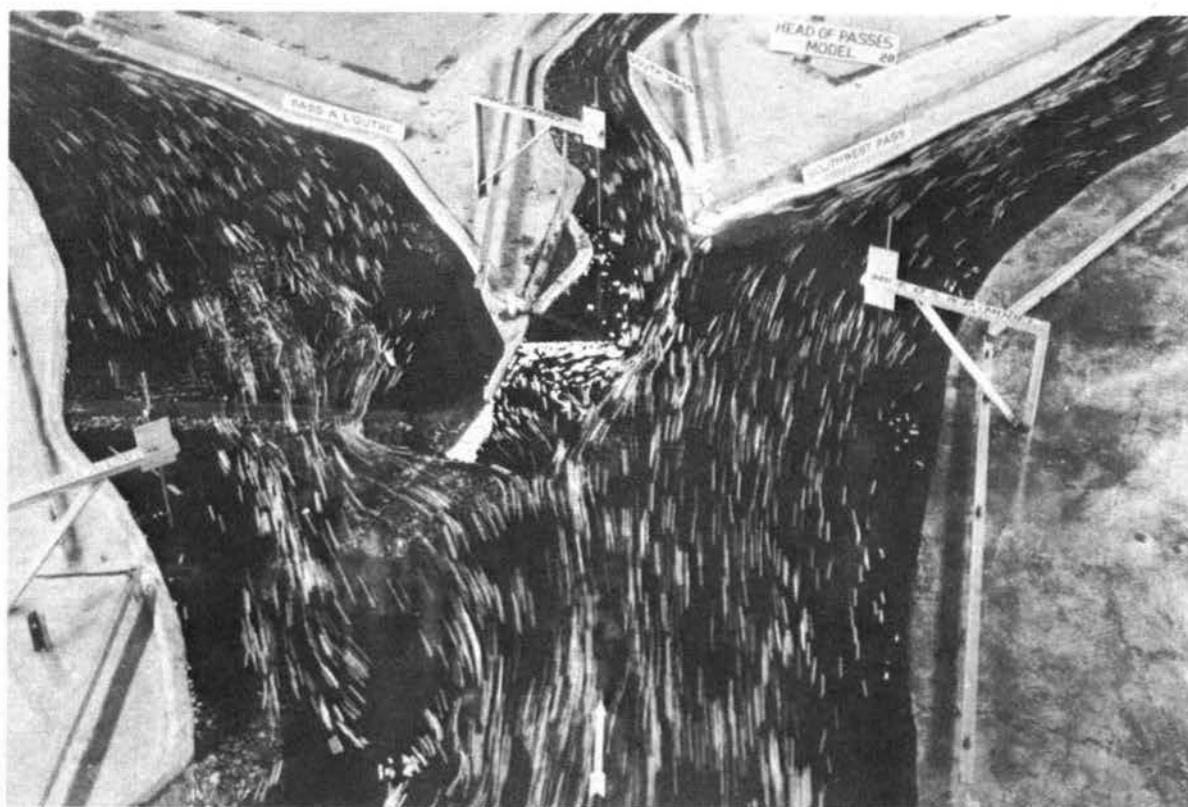
Photograph A6. Plan R-1; test 36; 20-ft stage. The upstream dike on the East Headland extension was endangered by the 20-ft flood stage

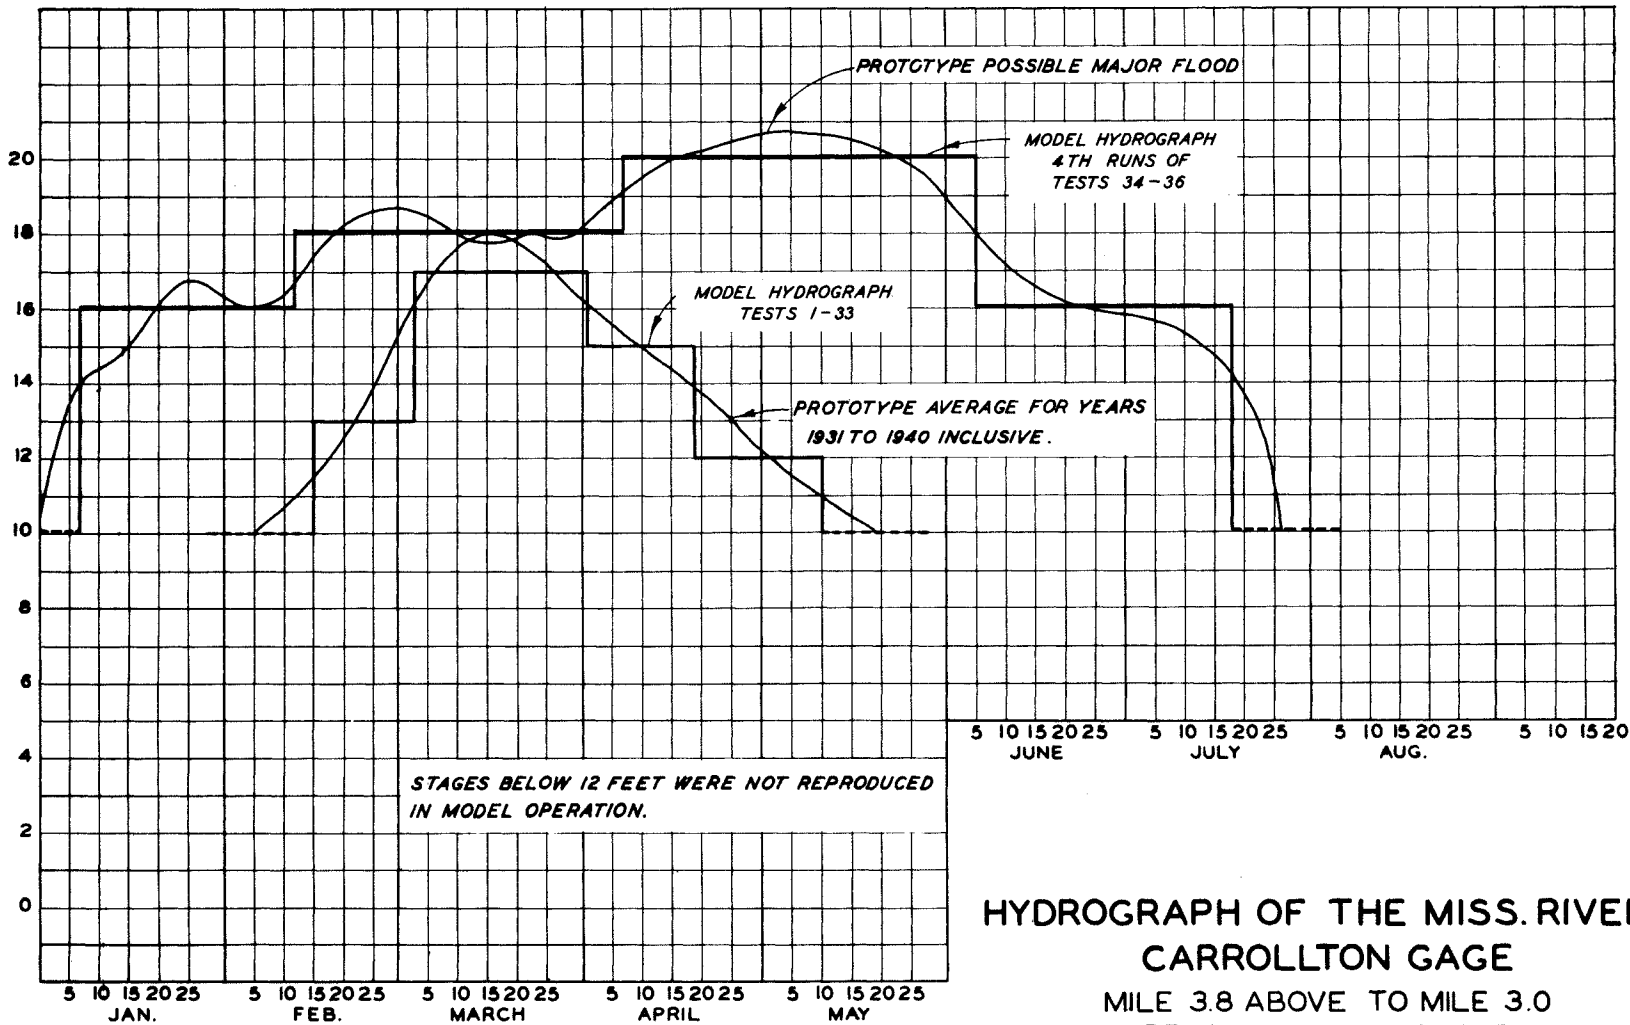
STAGE IN FEET, CARROLLTON GAGE (ZERO ELEV. -0.13 FEET M.G.L.)

**HYDROGRAPH OF THE MISS. RIVER
CARROLLTON GAGE**
MILE 3.8 ABOVE TO MILE 3.0
BELOW HEAD OF PASSES
